**INDUSTRIAL WASTE SITE  
IDENTIFICATION STUDY  
PART 1  
SOUTHEASTERN REGION**

**WATER AND EARTH SCIENCE ASSOCIATES LTD.**  
CONSULTING HYDROGEOLOGISTS, OTTAWA.  
IN ASSOCIATION WITH  
**GORE & STORRIE LIMITED**  
CONSULTING ENGINEERS, OTTAWA.

Re: Southeastern Region  
Industrial Waste Site Identification Study Phase II Part 1

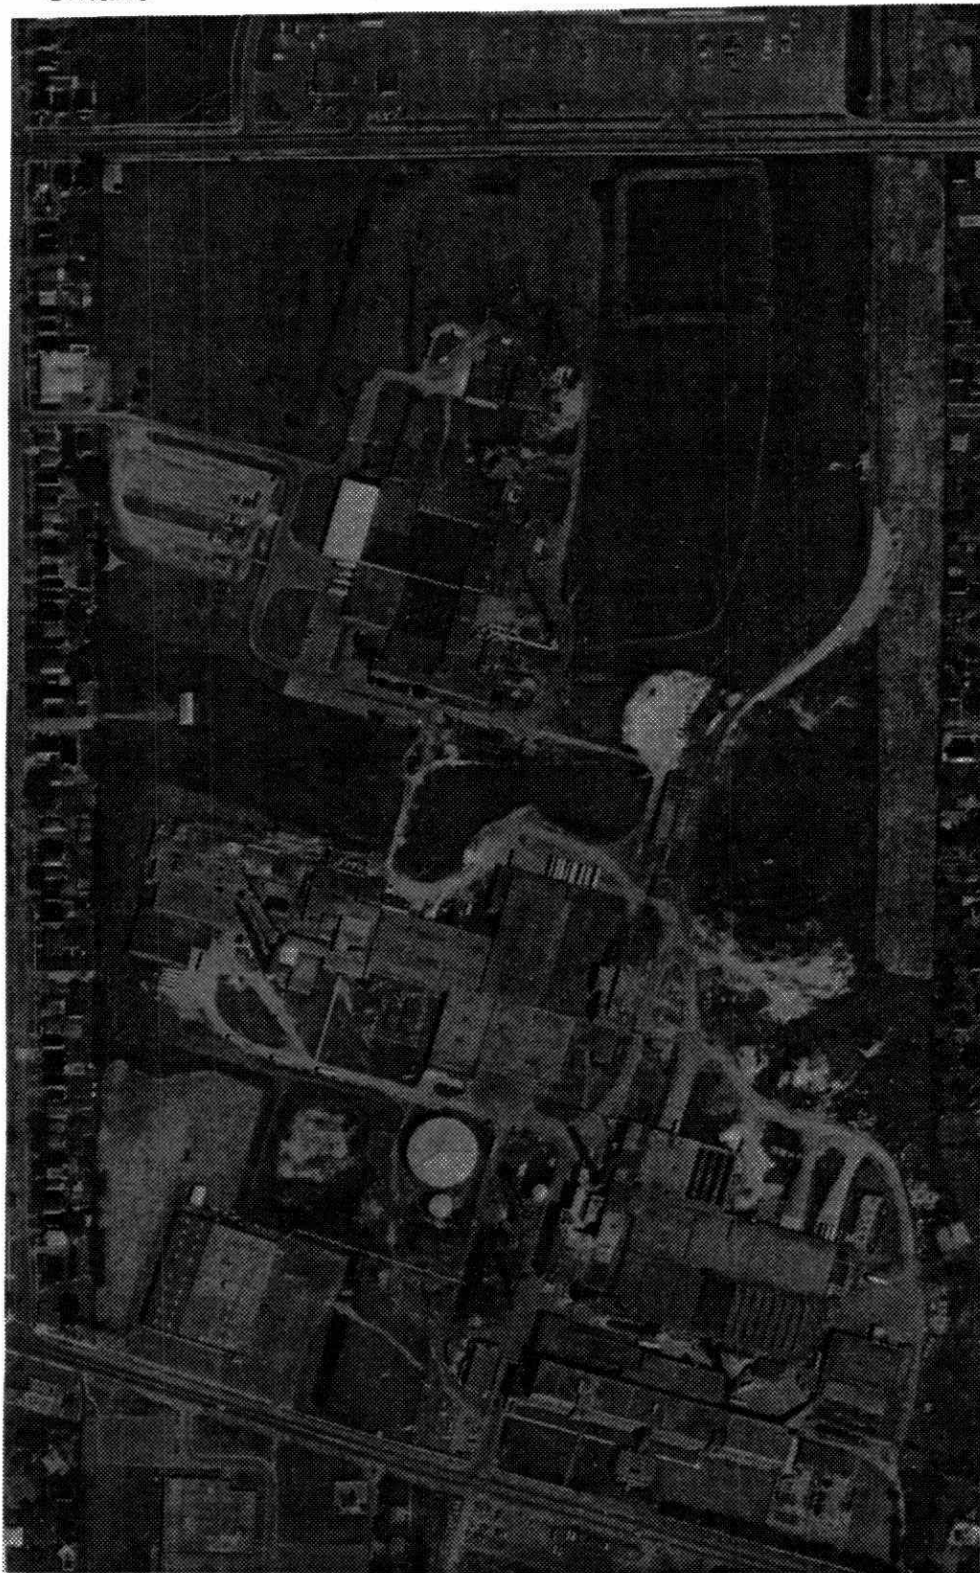
**FIGURE 2**  
**LEGEND**

- ..... APPROXIMATE  
LIMIT OF WASTE  
DISPOSAL AREA
- ⑥ MANHOLE WITH  
GAS READINGS
- /// AREA OF PONDED  
WATER IN DITCH
- GAS SAMPLING  
HOLE
- COLLECTOR SEWER
- + + RAILWAY SPUR LINE
- ② WATER SAMPLE  
LOCATION

As shown on Figure No. 2, the site is bounded by residential and commercial development. At the time of our field investigation, it was noted that a strip of the property along Second Street is currently being investigated for possible sale for commercial development.

Methane testing was carried out at three locations (figure No. 2) near the landfill site in holes approximately 1 metre deep. No trace of methane was noted, but it is felt that this can be attributed to the impervious nature of the cover material.

1. A comprehensive drilling programme should be undertaken on the Courtauld's property. It is recommended that a hollow stem auger be employed for the installation of a grid of holes to determine the following:
  - (i) The lateral extent of the landfill
  - (ii) The vertical extent of the landfill and characteristics of the cover material and underlying strata.

2. Included in the above noted drilling programme, it is also recommended that permanent groundwater sampling and gas monitoring stations be installed. Piezometric groundwater levels should also be recorded to confirm the direction of groundwater movement.

4. Depending on the results of the above noted investigation, further efforts will be necessary to either install a leachate collection system or to confine the leachate on the site.

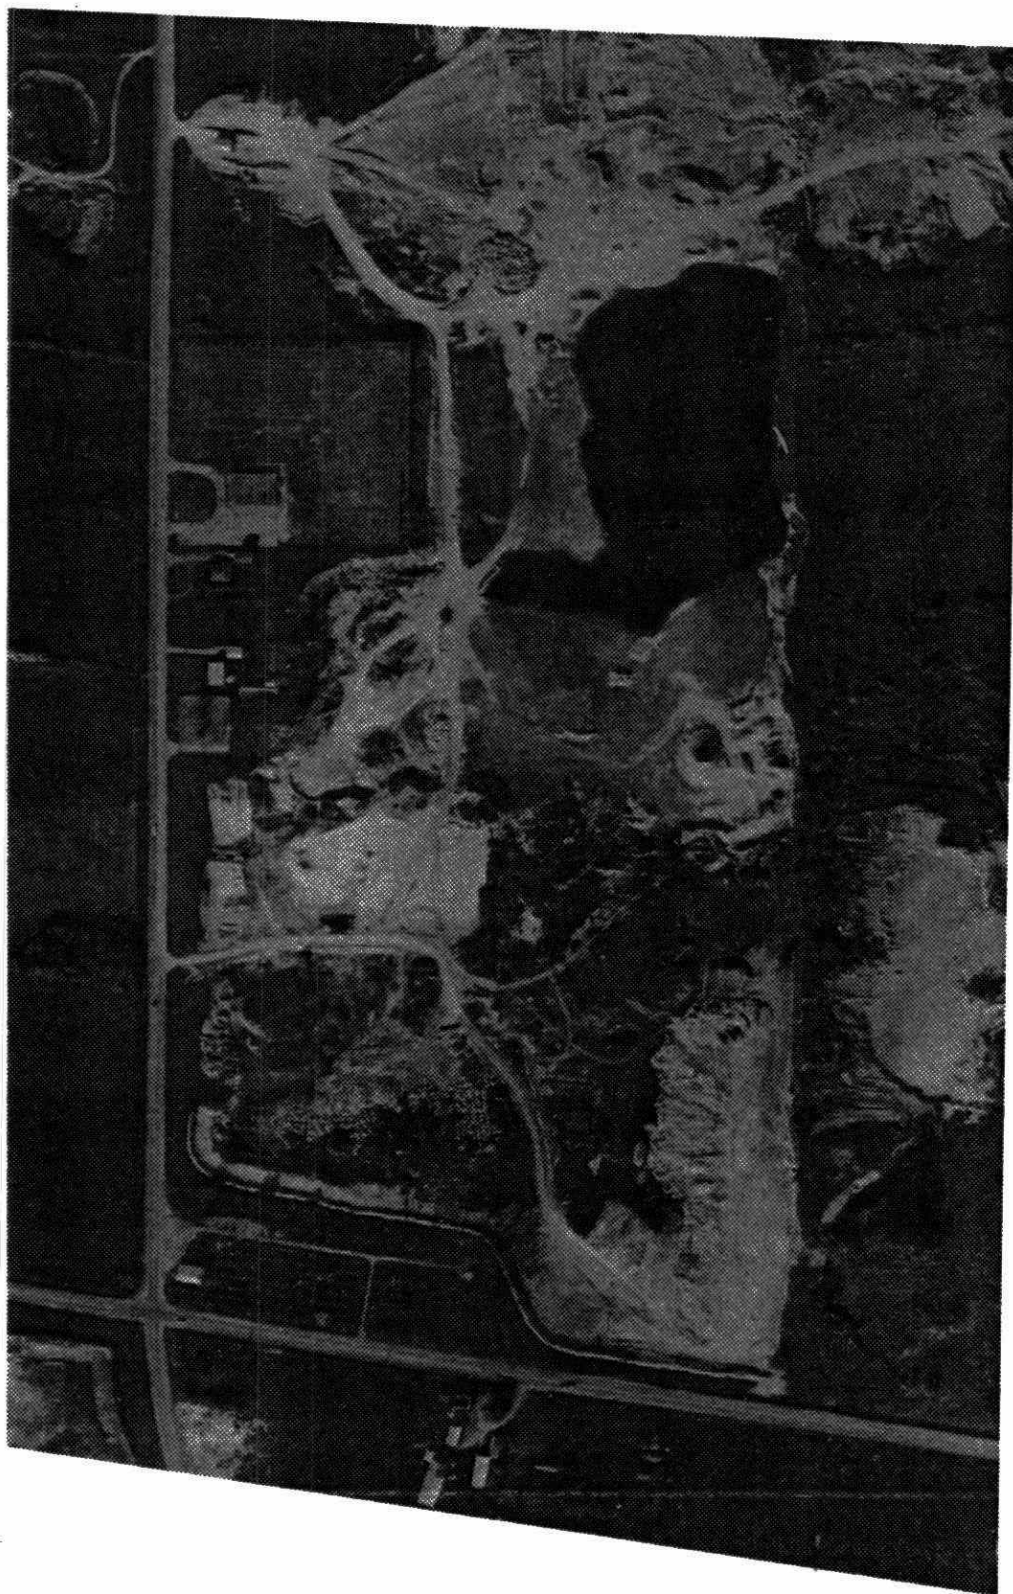
- Site 1: - asphalt, red bricks, cinder blocks, roofing materials, cement, partially burnt wood, metal scrap, glass, electrical cables, discarded household appliances, insulation, siding materials, tar, burnt tires, plastics, tin plate, lighting fixtures, ABS pipe, clothing, paper, some domestic garbage.
- Site 2: - cinder blocks, concrete, logs, wood, limestone boulders, bricks.
- Site 3: - limestone boulders, mortar, wood tar, one T.V. set, asphalt, stone, wood, well casing, aluminum siding, concrete (steel reinforced), red bricks, scrap metal, no domestic waste visible.

At Site 1, a trace reading (<5% combustible gases) was registered directly in the waste material, just north of Test Pit 6. When Test Pit 6 was dug, bubbling gas was observed in the groundwater which filled the pit to within 50 cm of the ground surface. This gas gradually dissipated.

After consultation with Ray Amell, M.O.E. Cornwall, a backhoe was rented and 4 additional test pits (Figure 2) were dug to below the water table. The analytical results from 3 bulk samples from Pits 4, 7 and 8 are outlined below and are summarized as Table 6. Test Pit 6 was not sampled because of the extreme degree of physical contamination in the pit (black colour, heavy petrochemical and burnt wood smell, gas production). This water has a 920 uMHos/cm conductivity and a PH of 7.50. It was obviously a strong leachate.

Based on the above mentioned results, it can be concluded that a leachate plume is moving in a southerly direction from Site 1. A variety of waste materials from the demolition of burnt buildings has been buried and piled here since May 1978. The leachate plume is less concentrated, as would be expected, both east and west of the primary flow direction. The leachate plume has already migrated off of the Gloucester Sand and Gravel Ltd. property.

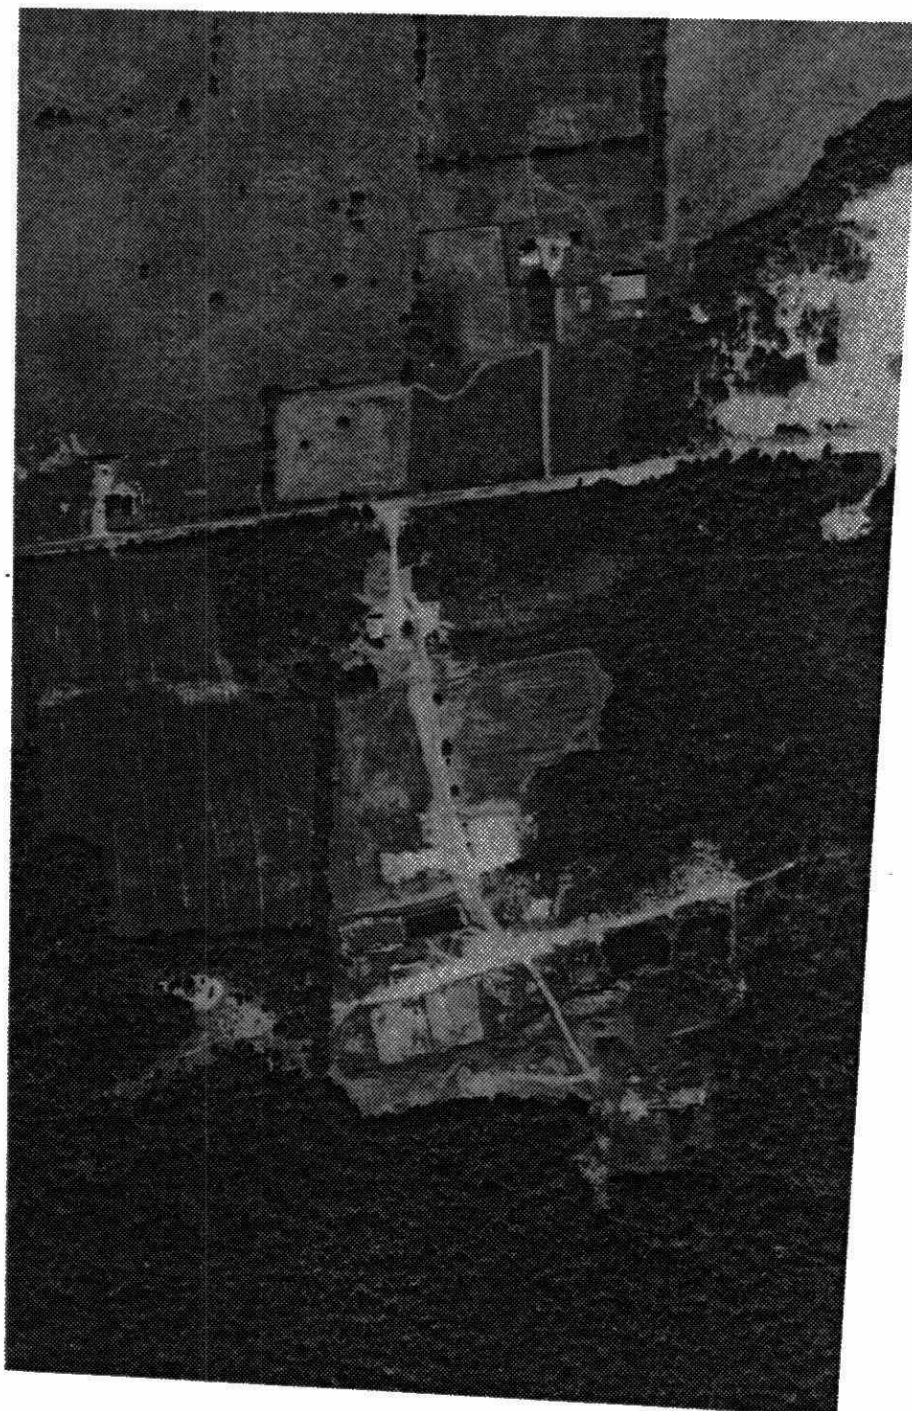
FIGURE 2  
LEGEND

..... LIMIT OF WASTE DISPOSAL AREA

Most of the drums are partially rusted.

Area where many old chemical drums have been disposed. Most of these are heavily rusted.

In addition, there are several derelict fuel oil trucks on the site which were used for hauling waste. Numerous small depressions in the sandy ground surface are coloured (red, browns, green) indicating the infiltration of some chemical substance concentrated more at site Location 4, but are present throughout the lagoon areas of the site.

It is recommended that the findings of the Morrison Beatty Report be reviewed in detail before any additional monitoring work is undertaken. In the long term, the possibility of bedrock aquifer contamination should be established and adjacent well waters should be analyzed in a comprehensive manner (i.e. for organic chemicals as well as inorganic elements) on a suitable regular basis.
